Quality Assurance in Capital Projects

This article is an introduction to Quality Assurance (QA) and presents a few case studies that can be used to describe XPS' QA approach in action during testing and design, fabrication and construction.

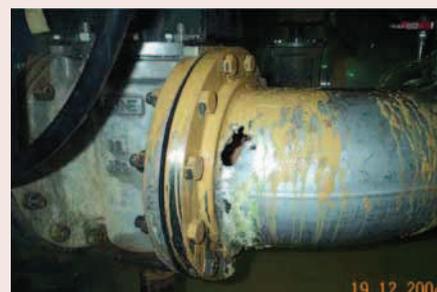
During the expansion of a zinc leaching operation, new equipment was added to an existing plant to recover precious metals from leaching residues. The most critical part of the expansion was the fabrication and construction of three new leach tanks. The environment consisted of leaching the residue with a solution containing 100g/l H_2SO_4 at 95°C, redox potential = 350mV and maximum chloride content of 50ppm. Another section of the plant had similar leaching tanks operating at approximately 80g/l H_2SO_4 at 90°C. The old tanks were lined with acid resistant masonry and respective membrane. However, the owner requested that the new tanks had to be built using metallic materials only. Corrosion tests of candidate materials were performed with solution from the old tanks with their parameters adjusted to the new conditions. The alloys tested were 904L, 254SMO, Zeron 100, 20Cb3, and Inconel 625. The selection of some of the candidate materials was based on experience in similar environments. Following the corrosion tests, alloy 904L was selected. The QA program for the tanks proceeded with detailed design review, inspections during fabrication and construction. However, the QA program was restricted to the tanks only. Approximately three weeks into commissioning, leaks developed along pipelines, valves and flowmeters, all due to corrosion. The photo (right) illustrates a corroded

pipe spool at the tank discharge line. The condition of the tanks became the main concern since failure of the tanks would lead to a major shutdown and re-assessment of the project. Corroded pipe spools, valves and flowmeters were sent to the Materials

Corroded pipe spool from high acid leach tank

Technology laboratory of XPS for analysis. The analysis indicated that all corroded components were made of stainless steel type 316 rather than the 904L alloy used for the tank. The tanks were emptied and inspected and no corrosion was found. In conclusion, an adequate QA program was implemented during the tank fabrication but little attention was paid to ancillary equipment. All corroded equipment was replaced with 904L alloy.

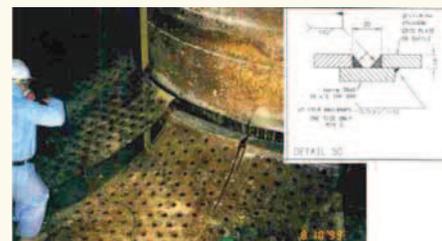
A sulfuric SO_2 gas converter from a sulfuric acid plant failed only a few months after it went into service causing a prolonged smelter shut-down. The failure consisted of the collapse of one catalyst bed, consequently causing the converter to lose its functionality. The equipment had to be opened and the catalyst removed to facilitate equipment inspection. Inspection revealed that one of the longitudinal welds connecting two bed segments had failed causing the bed to collapse. Close examination showed that the failed weld was intermittent instead of continuous. However,

the construction drawings clearly specified continuous welds and provided clear weld design details. The photo (right) depicts the collapsed bed and the weld design detail from the fabrication drawing. The investigation clearly showed that in this case the material selection, design and specifications were all properly done. However, the project lacked proper surveillance during construction. The lesson learned here is that the QA cycle has to be complete, from the initial project development to execution. The exclusion of one QA step can lead to costly consequences.

Catalyst bed failure

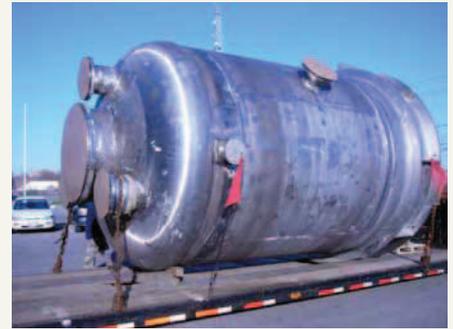
initiated and served to support ancillary equipment selection. During the testing, a decision was made to include acid resistant masonry and mortars in the program and to consider the feasibility of designing the autoclave shell with masonry lined carbon steel complete with membrane materials. Finding the proper acid resistant brick, mortar and membrane materials was very challenging due to the high acid concentrations. Tests were performed in autoclaves and specimens were exposed to both the vapor and liquid zones of the pilot autoclave. Following the autoclave tests, all specimens were submitted to SEM and chemical analysis as well as mechanical testing. The test duration was approximately two months and cost approximately \$150K CAD. The final material selection for the autoclave lining was based on the tests results and the total cost of the plant was \$60M CAD. During the plant commissioning only minor problems were found at the autoclave cover seal. This was rapidly overcome and no other major problems were observed.

Autoclave shell

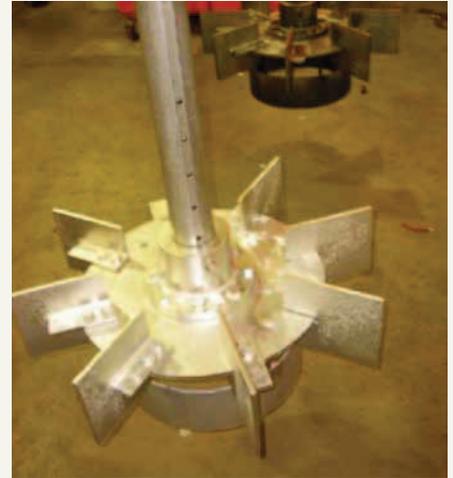
Mixer and shaft

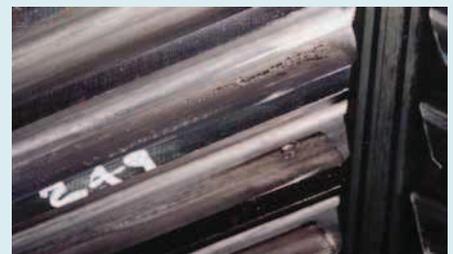
After the failure of a hoist bull gear from an underground mine, a new fabricated gear was installed and started to develop progressive pits on its teeth face immediately after it went into service. The photo (right) depicts the details of progressive pitting on one tooth of the newly installed gear. Only the original drawing and performance parameters had been used as procurement documents. Therefore, no quality assurance dossier was delivered with the gear. The gear hub and spokes were made of welded carbon steel while the rim was made of quenched and tempered low alloy steel and welded onto the spokes. The gear supplier initially suggested that the pitting was due to normal run in. However, the owner and the supplier decided to perform weekly inspections to assess the progression of the pitting damage. After three months in operation it was concluded that the pits were in fact progressive pitting, which could lead the gear to catastrophic failure. Nothing had been changed in the mine regarding the hoist loading and speed as well as the lubrication system. The gear had also been replaced in kind with exactly the same dimensions as the original one. Close examination revealed that the pitting damage followed a pattern, being very pronounced every sixth tooth. Therefore, there was evidence of potential dimensional errors on the gear which had most likely originated during the gear fabrication. A

detailed dimensional inspection was then performed on site and the results indicated that some teeth were thicker than others. Furthermore, the thicker teeth followed a pattern of every sixth tooth, consistent with the pitting pattern. The supplier then proceeded to inspect its own gear cutting equipment and the defective teeth were traced back to off-spec cutting tools. Another gear had to be fabricated to replace the defective one. The lesson learned here is that a proper QA procedure, which included dimensional checks of the fabricated gear, would have prevented the failure. Since then, a detailed specification has been used for the procurement of bull gears, which amongst other things has requirements for inspection and testing plans, including detailed dimensional inspections at the fabrication shop.

Progressive pitting damage on gear tooth face
