# Recurring Failures of Rod Mill Liner Bolts

## Materials Technology

Presented by Wilson Pascheto

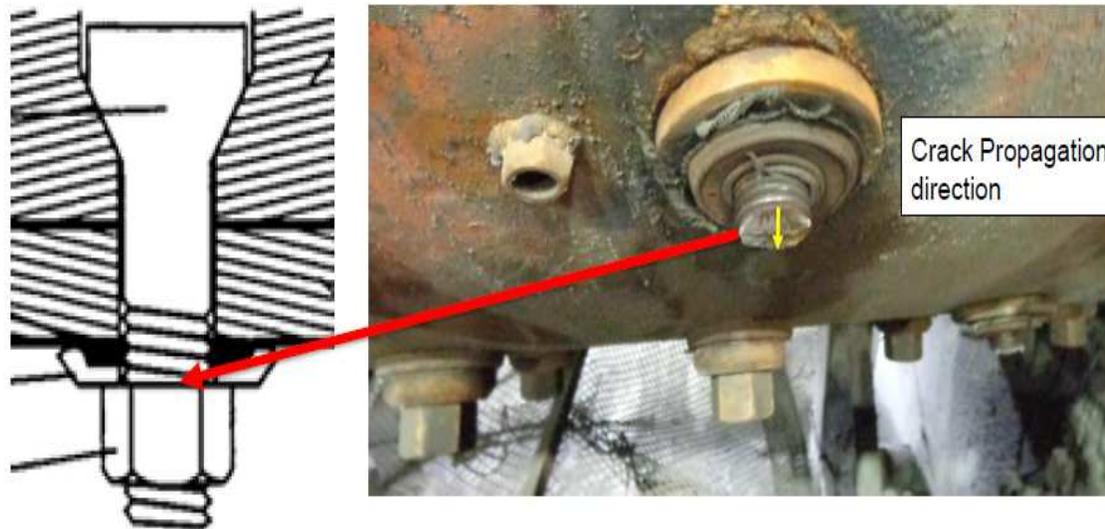
Failure Location: 1<sup>st</sup> thread from the nut bearing face

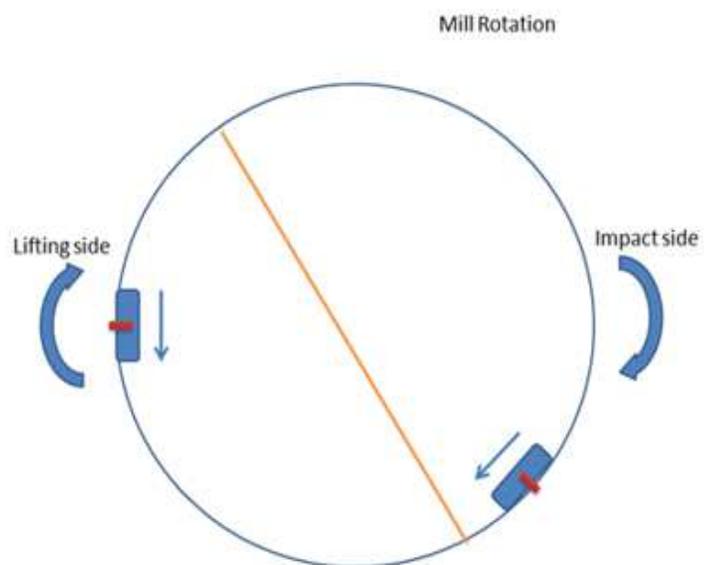
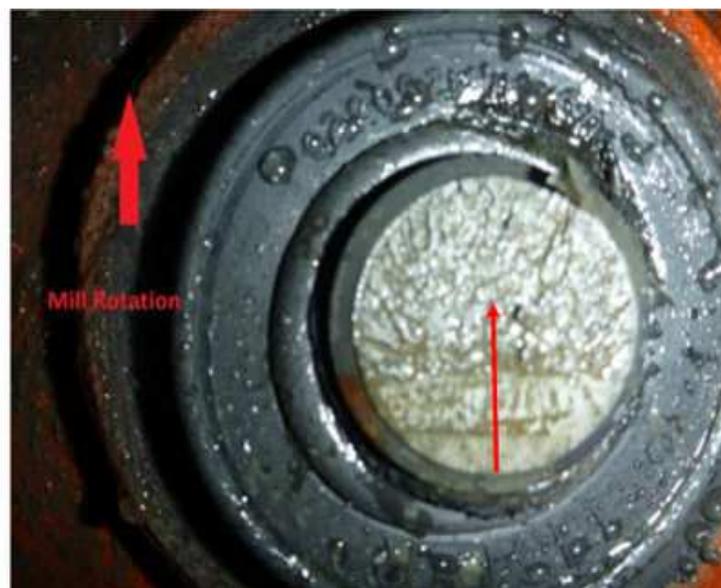
## Direction of Crack Propagation and Mill Rotation

- Bolt failures occurred by fatigue. The direction of fatigue crack propagation was in the direction of mill rotation
- Fatigue failures occur when external cyclic loads are higher than the bolt clamp load
- The rubber seal between the mill shell and bolt washer affect joint relaxation, and therefore loss of clamp load
- The initial clamp load of a bolt is affected by thread cleanliness and quality
- Better control of bolt clamp load reduced bolt failure rates.

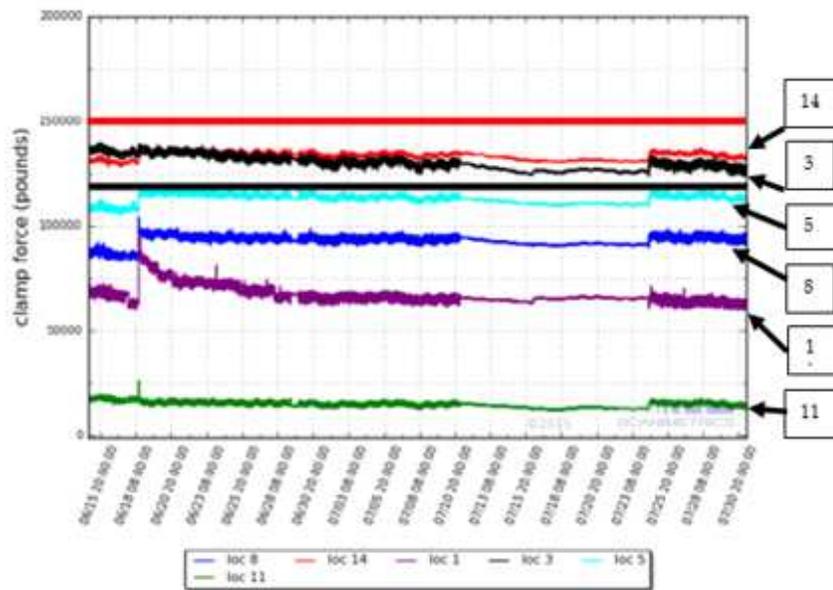
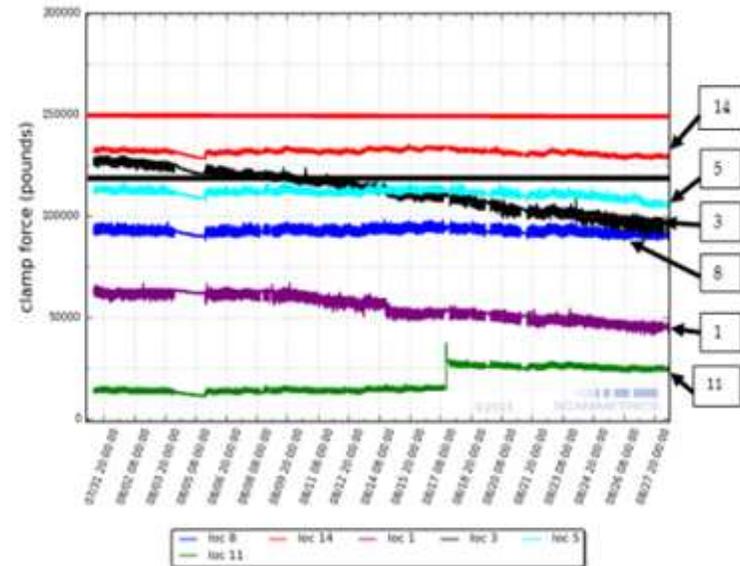
## Clamp load vs time

- All bolts relaxed with time, as it is evident by the loss of clamp load with time
- Bolts 1, 3 and 5 experienced the highest losses of clamp load. These three bolts were the closest to the mill discharge end.
- High loss of clamp load appeared is independent of initial clamp load but highly dependent on bolt position, as the highest losses were near the discharge end.

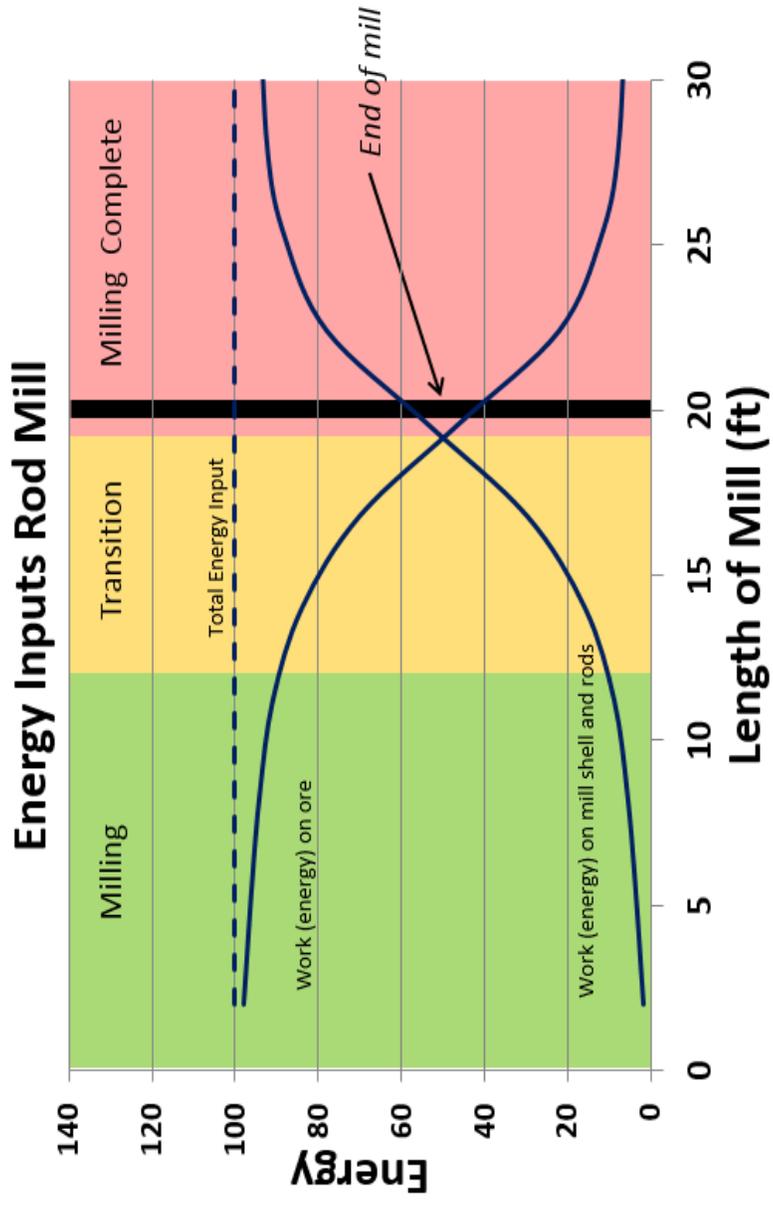
## Failure positions in “A” and “B” mill

- Bolt failures was a function of bolt position rather than initial clamp load. Therefore, the failures appeared to be mostly related to bolt loosening due to the extent of impact and vibration at the discharge end of the mill
- An energy model has been proposed to explain the effect of ore hardness, mill speed, ore throughput and liner design on the energy distribution across the length of the mill as it relates to grinding and interaction between mill rods and shell liner
- Changes in liner design are underway to address energy distribution and reduce impact in the mill.
