# Recurring Failures of Rod Mill Liner Bolts

## Materials Technology

Presented by Wilson Pascheto

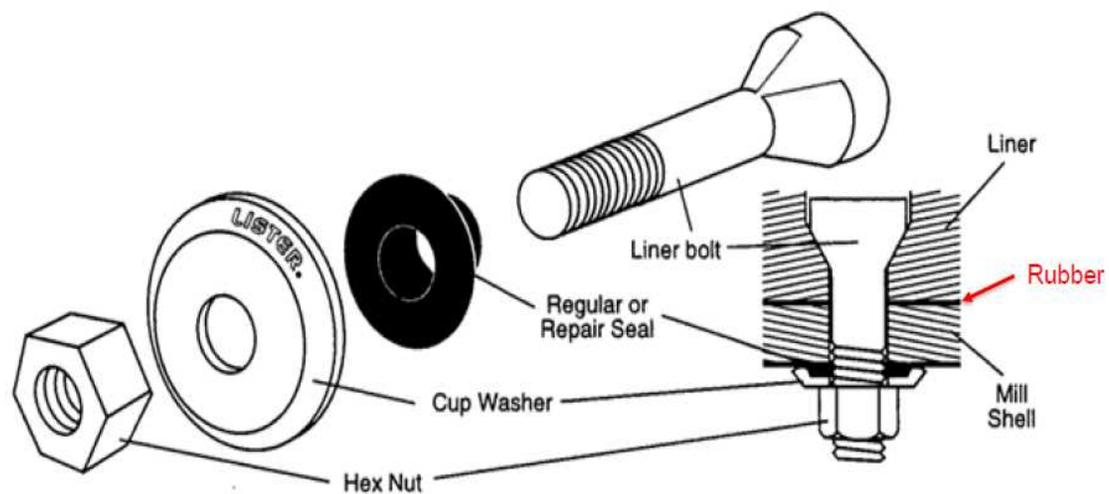
## Schematic Representation of Joint Assembly

Failure Location: 1<sup>st</sup> thread from the nut bearing face

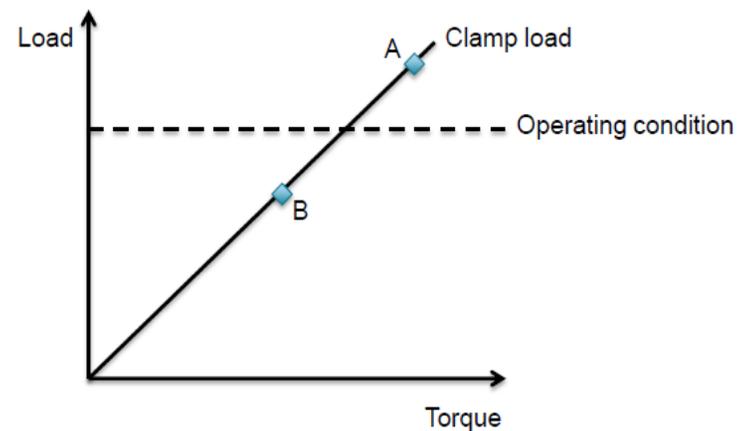
## Schematic Representation of Bolt Loads

A: Torque applied creates a clamp load higher than operating condition. Bolt is unaffected by load cycle.

B: Torque applied creates a clamp load lower than operating condition. Bolt assembly will be exposed to load cycle.

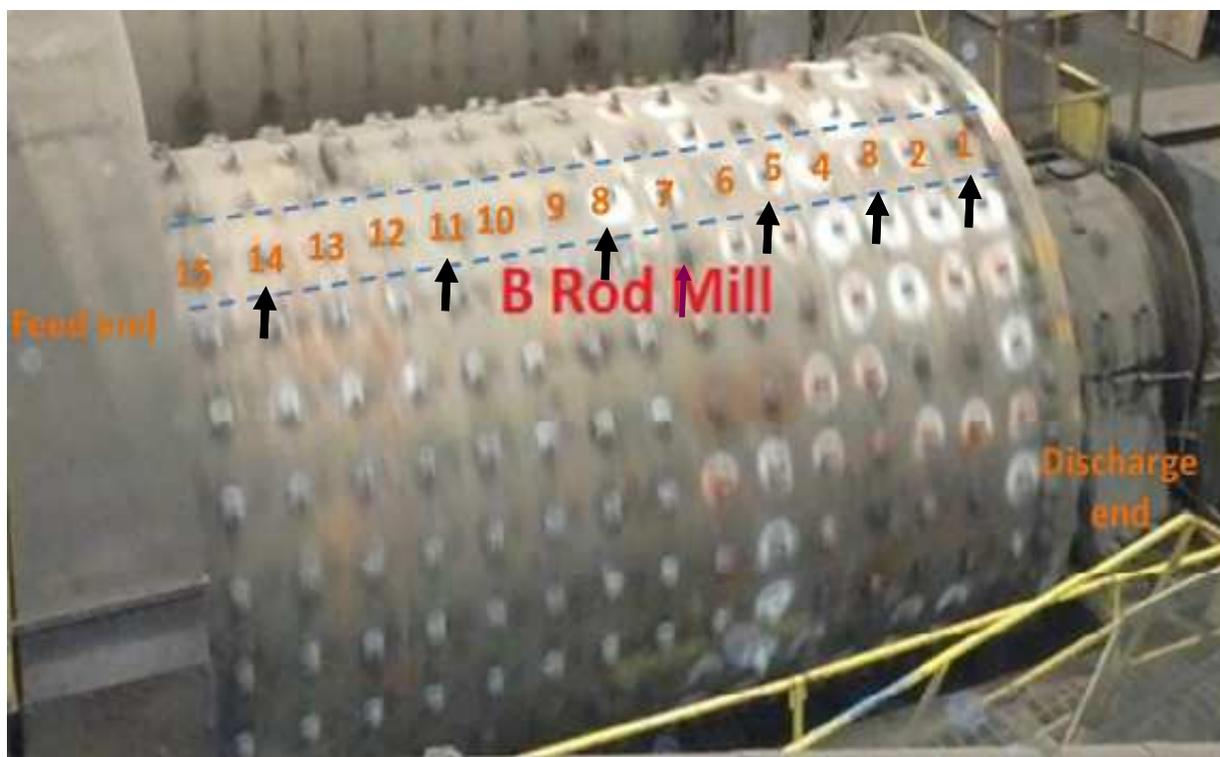
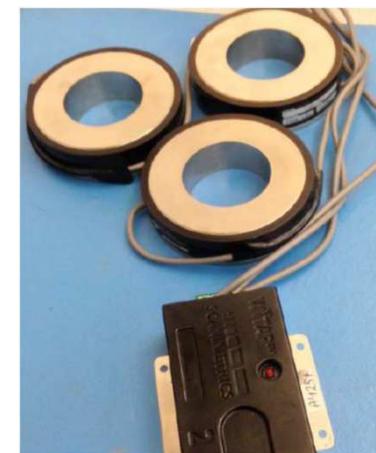
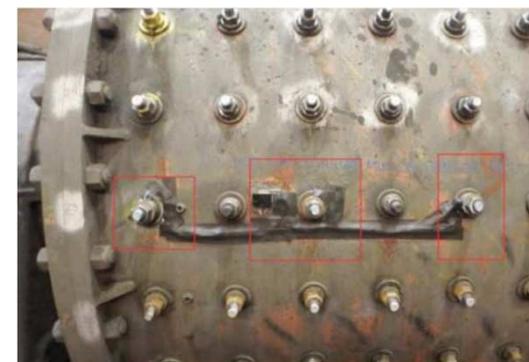
## Clamp Load Tests / Load Cell Position

- All bolts relaxed with time, as it is evident by the loss of clamp load with time
- Bolts 1, 3 and 5 experienced the highest losses of clamp load. These three bolts were the closest to the mill discharge end.
- High loss of clamp load appeared is independent of initial clamp load but highly dependent on bolt position, as the highest losses were near the discharge end.

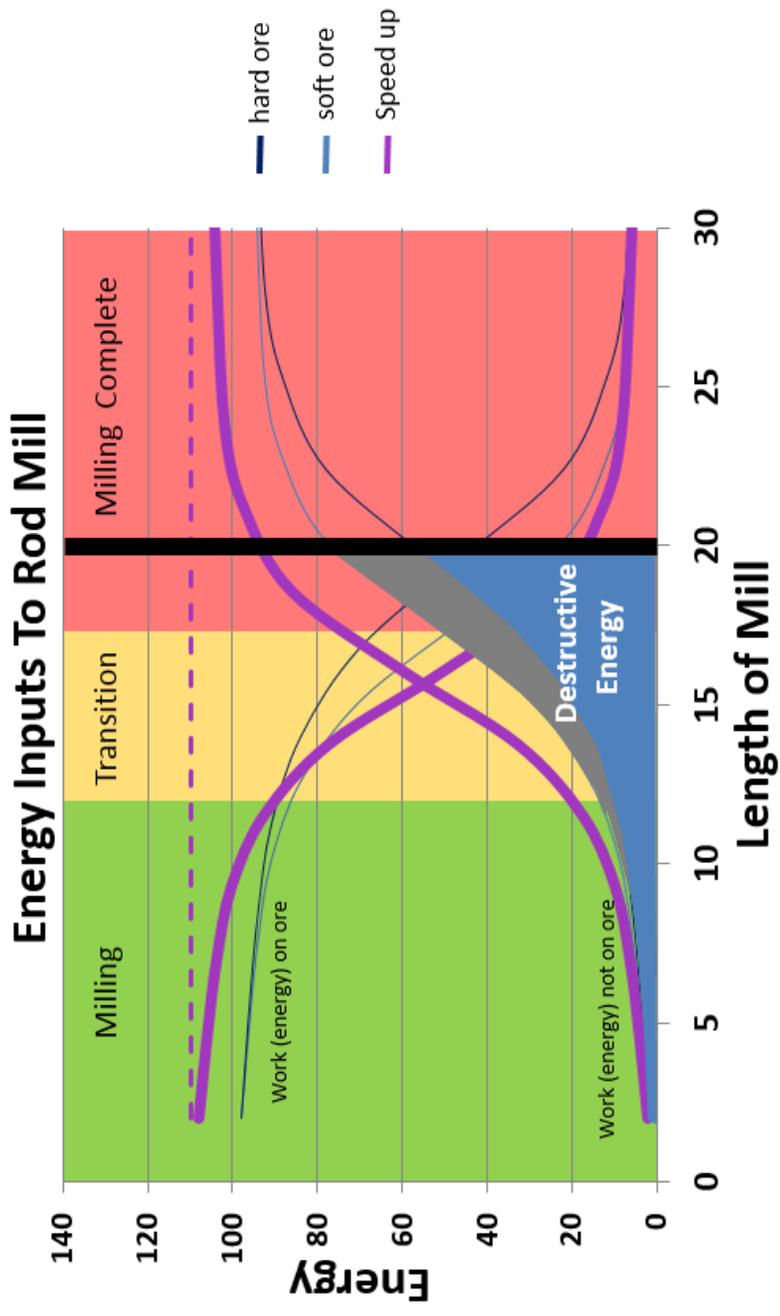
## Speed Up – Add More Energy

- Bolt failures was a function of bolt position rather than initial clamp load. Therefore, the failures appeared to be mostly related to bolt loosening due to the extent of impact and vibration at the discharge end of the mill
- An energy model has been proposed to explain the effect of ore hardness, mill speed, ore throughput and liner design on the energy distribution across the length of the mill as it relates to grinding and interaction between mill rods and shell liner
- Changes in liner design are underway to address energy distribution and reduce impact in the mill.
